**RE: The Public Montessori at Central, Room 128  
4406 Okemos Road, Okemos, Michigan  
ERG Project No.: 240451**

On Wednesday, September 4, 2024, ERG conducted a visual inspection and air quality testing in Room 128 following carpet cleaning and drying which was performed by GFL Environmental. The cleaning was requested following the observation of what was believed to be a dime sized area of visible mold on the carpet.

DIGITAL PHOTOGRAPH LOG

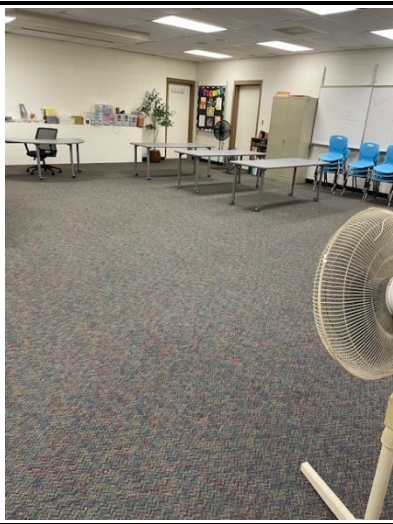
<p>1. Room 128 as viewed on the morning of September 4, 2024. The room was clean, had no musty odors and the carpet was dry.</p>

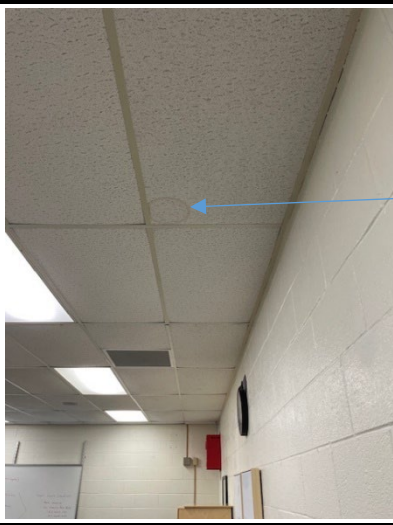
<p>2. A watermarked ceiling tile was observed near the entry door. No visible mold was observed in the tile.</p>

Lastly, remove the water marked ceiling tile and replace it with a new tile.

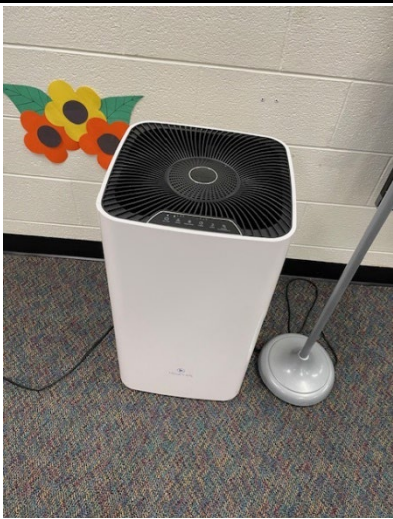
<p>3. A room air filter was present and in operation in the room.</p>
